Ruby Gulch Tailings Reclamation

- Generated by the Whitcomb Mill
- Cyanide Vat leach tailings dumped in Ruby Gulch during early mining
- Used as construction material for area projects
- 1 million cubic yards left in the drainage at mine closure

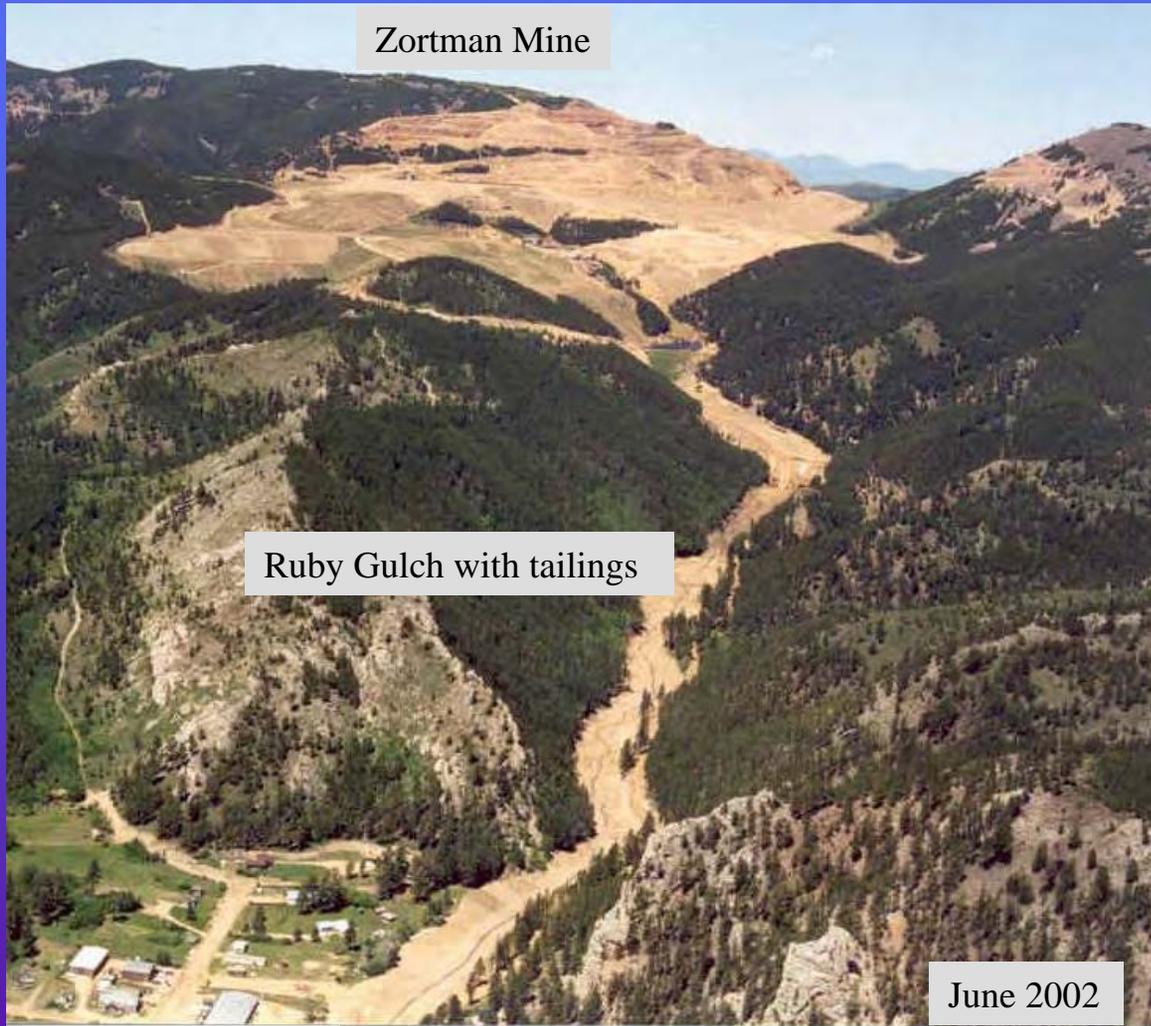
Ruby Gulch with tailings

June 2002

- Migrated downstream through the town of Zortman
- Covers the Ruby Gulch Drainage

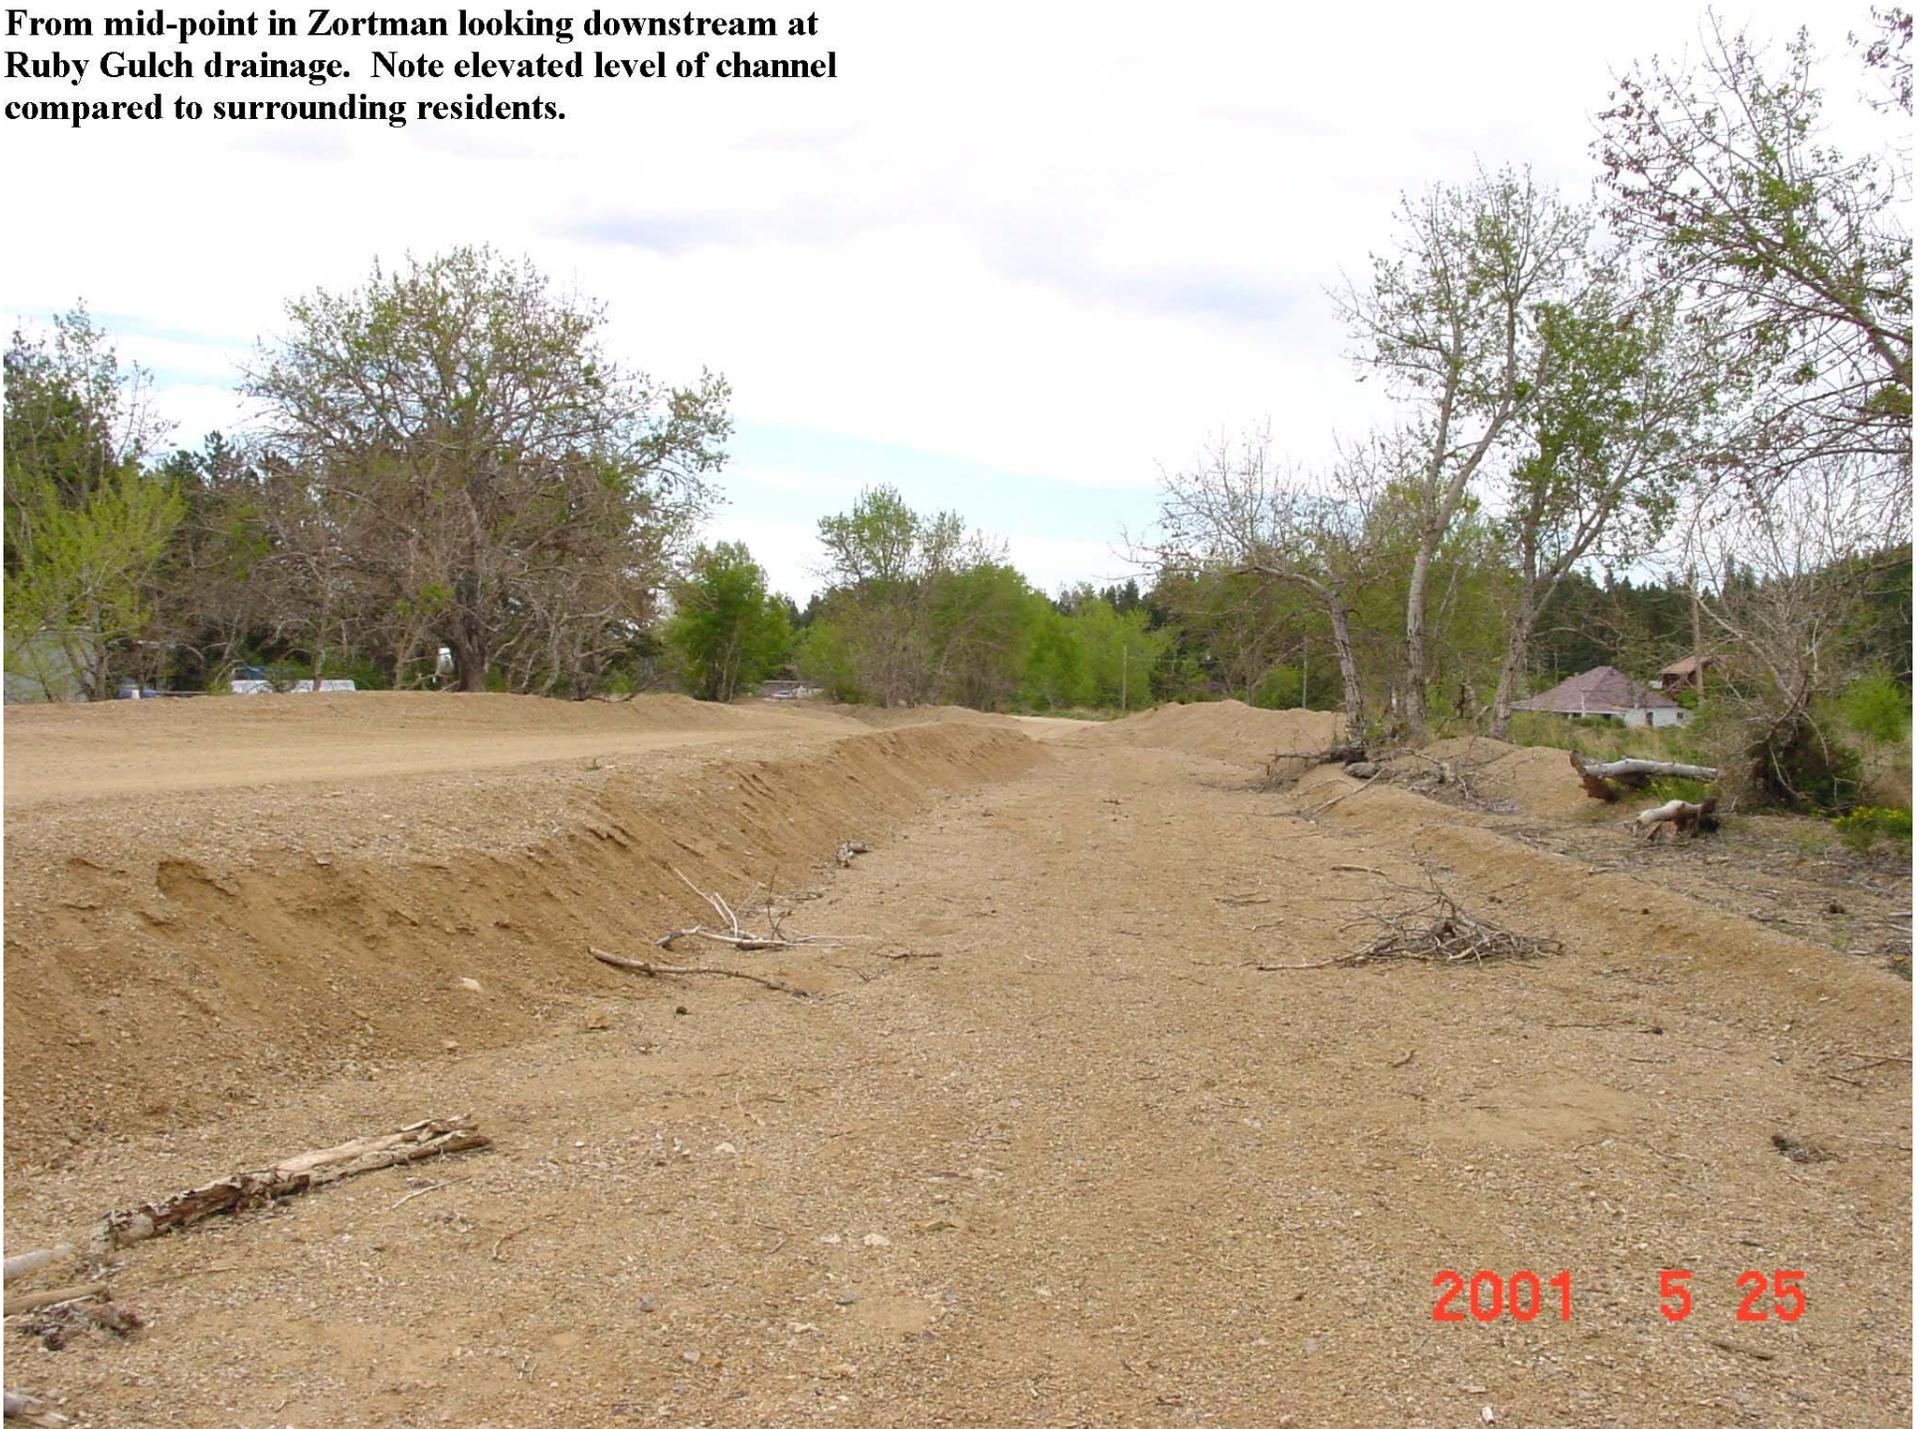
2001 5 25

From mid-point in Zortman looking downstream at Ruby Gulch drainage. Note elevated level of channel compared to surrounding residents.

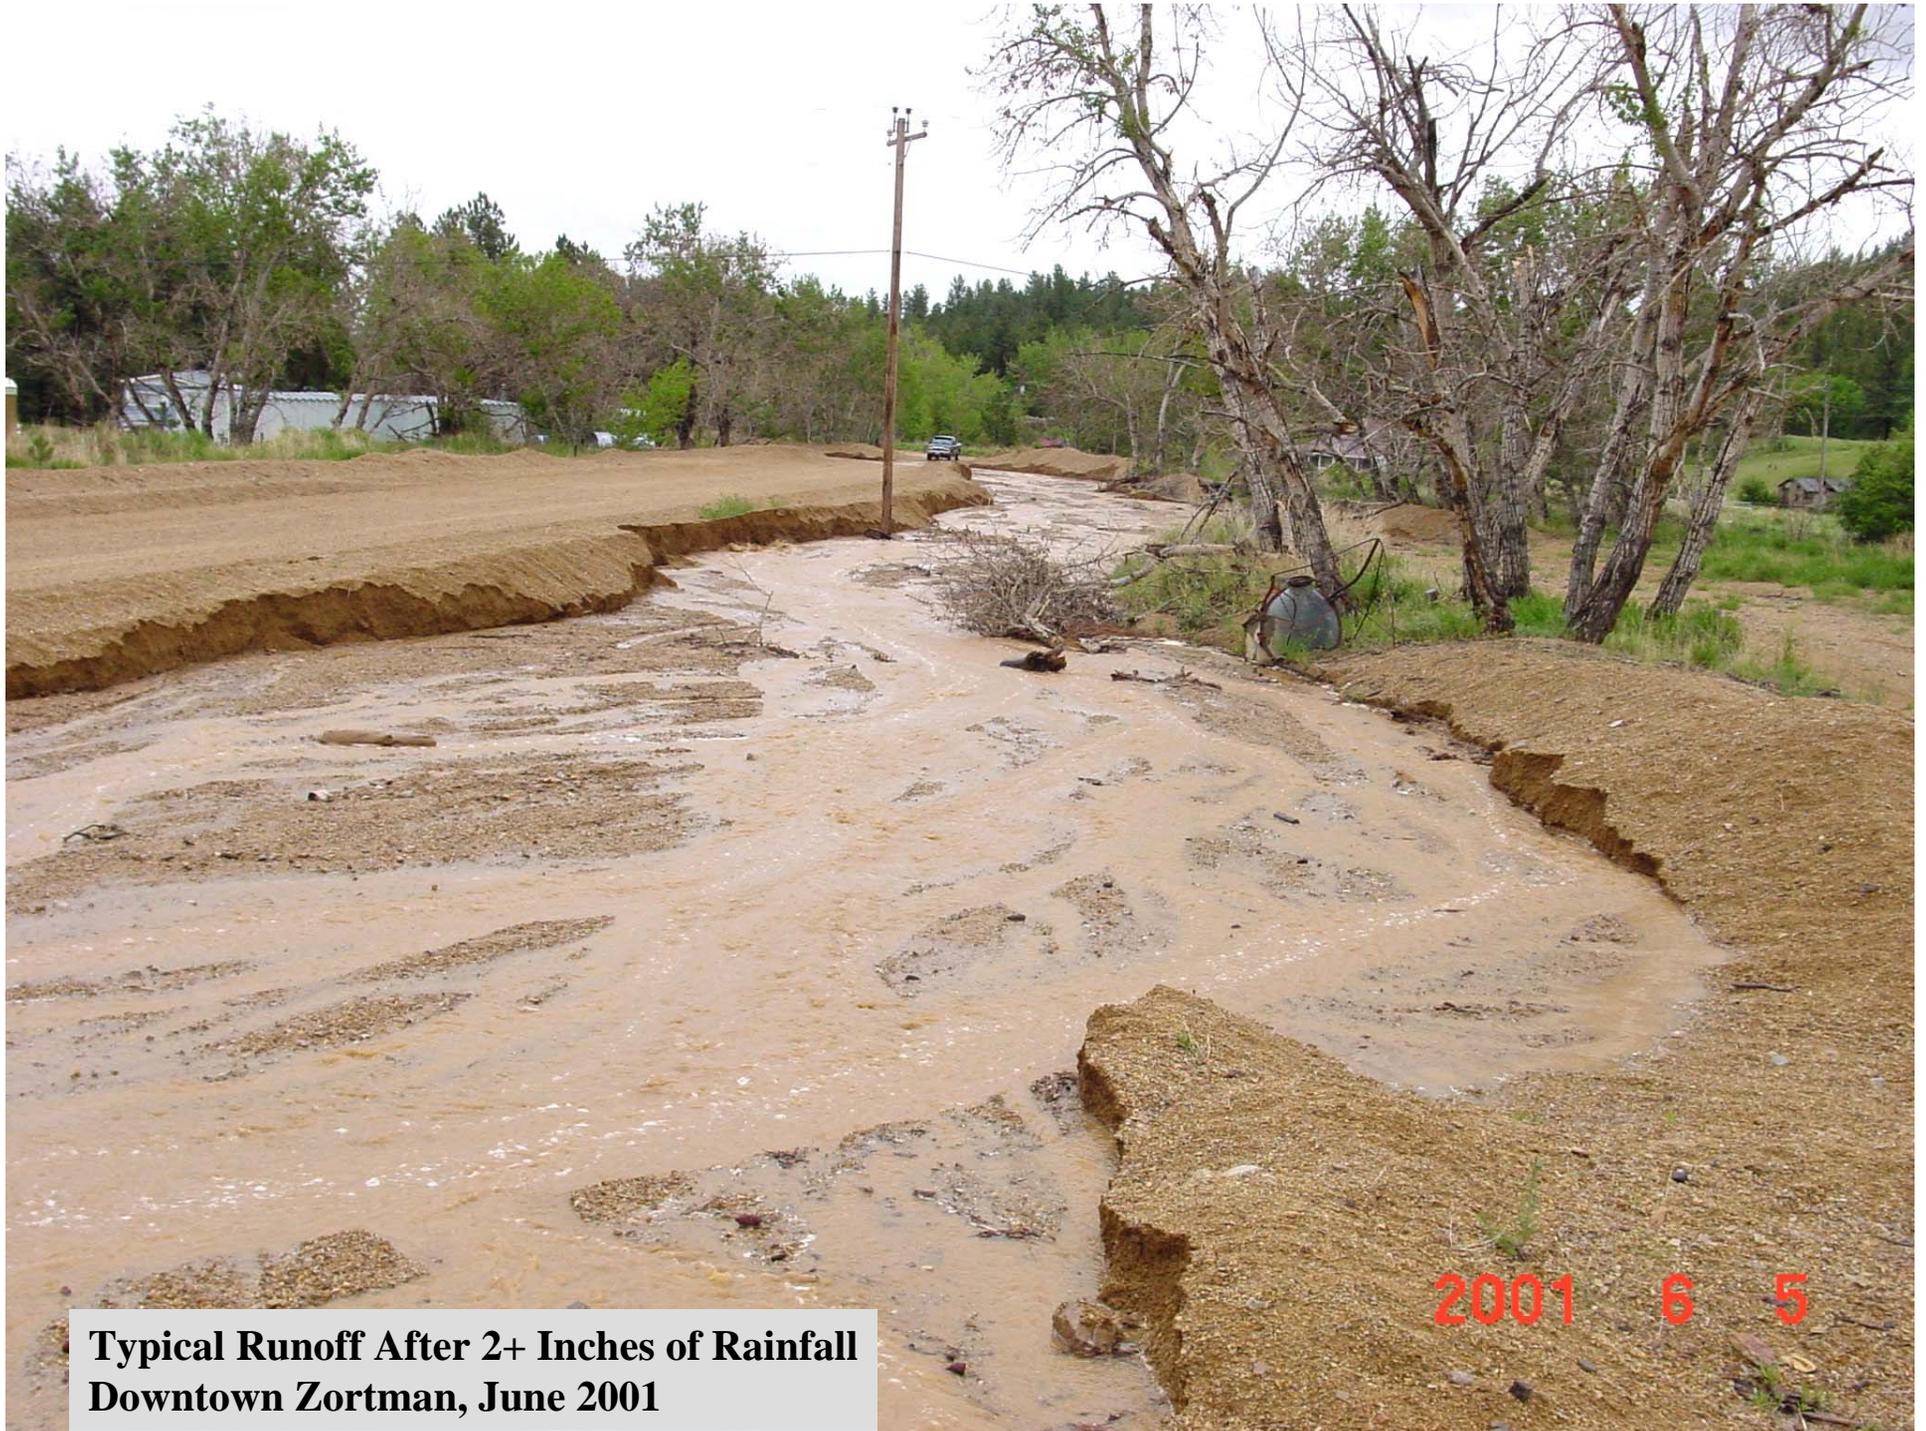
2001 6 5

**Typical Runoff After 2+ Inches of Rainfall
Downtown Zortman, June 2001**

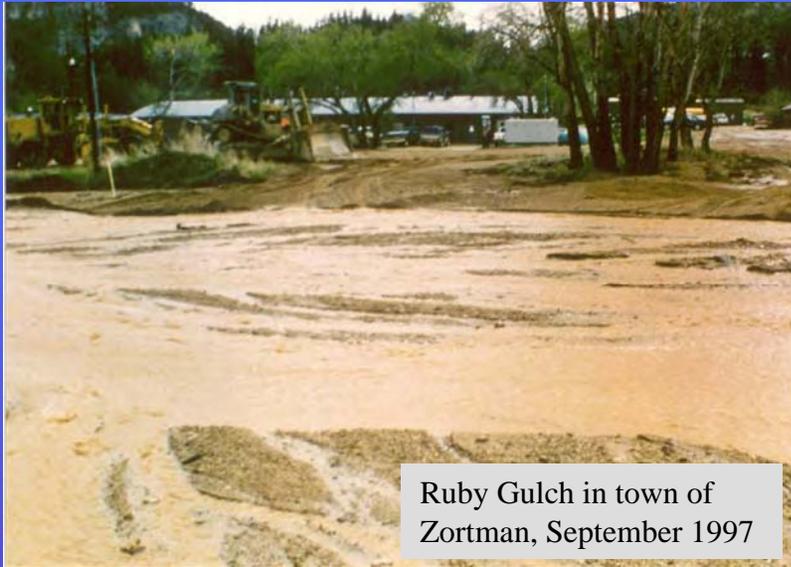
Ruby Gulch in town of Zortman, September 1997

- Unstable in the Streambed
- Long term maintenance problem for town and mine reclamation access
- Valuable as construction and reclamation material

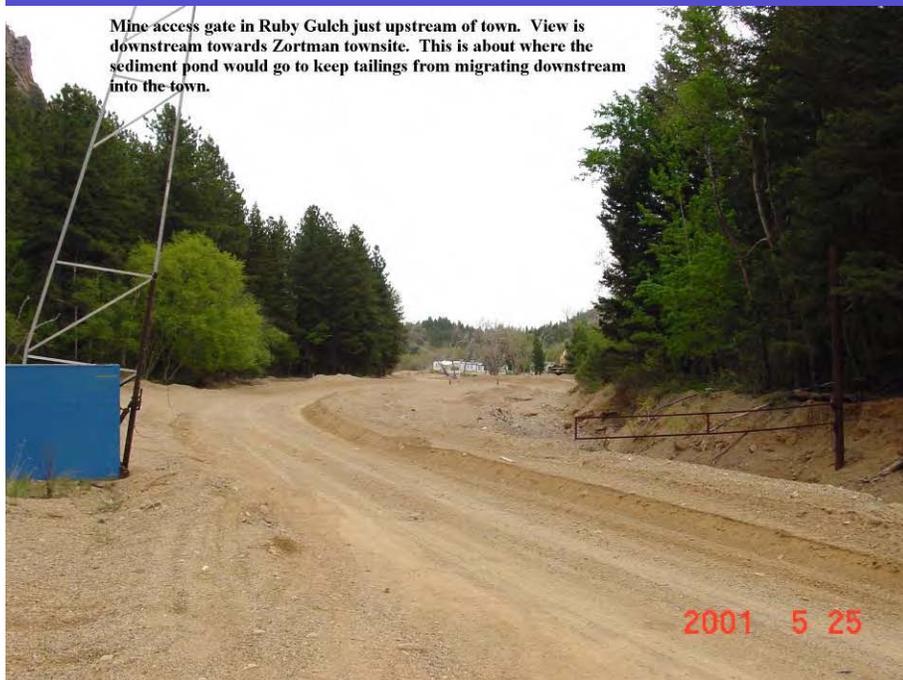
2001 5 25

Mine access gate in Ruby Gulch just upstream of town. View is downstream towards Zortman townsite. This is about where the sediment pond would go to keep tailings from migrating downstream into the town.

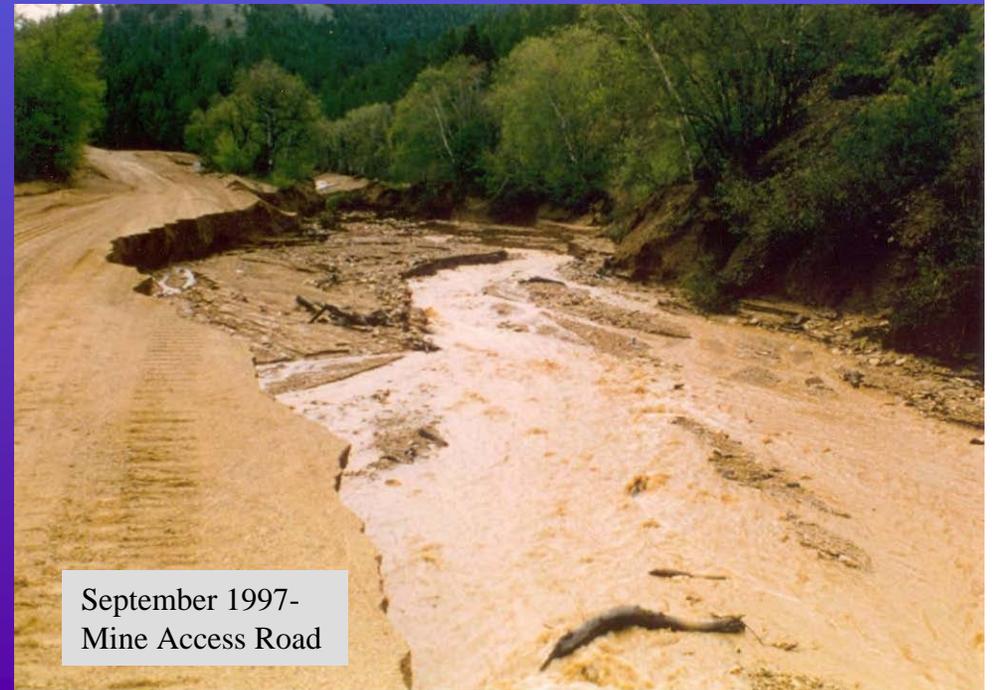
September 1997-
Mine Access Road

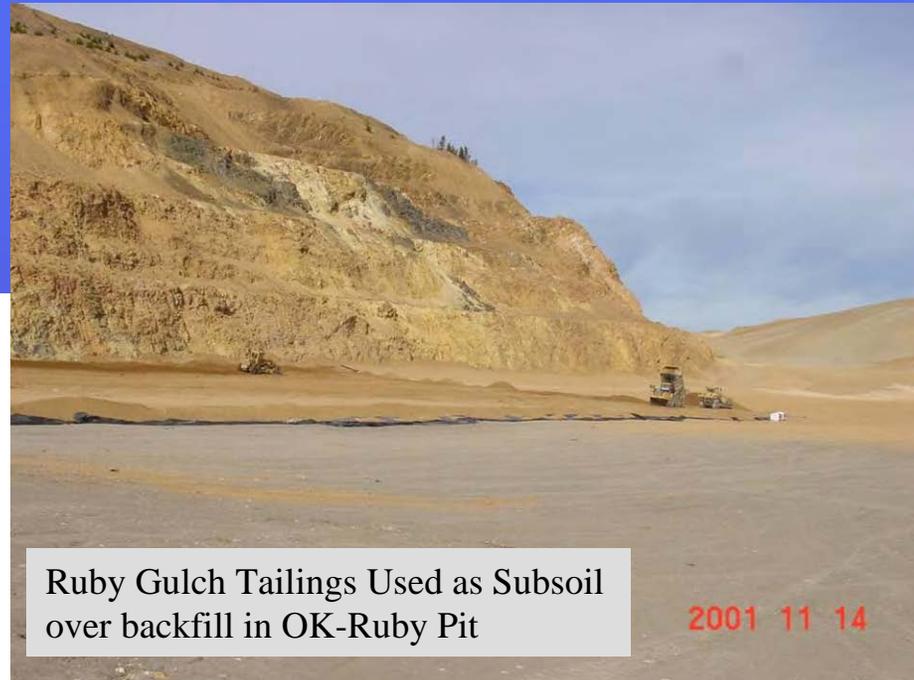
2001 11 14

Ruby Gulch Tailings Used as Subsoil
over backfill in OK-Ruby Pit

Most tailings
were used as
subsoil at the
Zortman Mine
during mine pit
reclamation

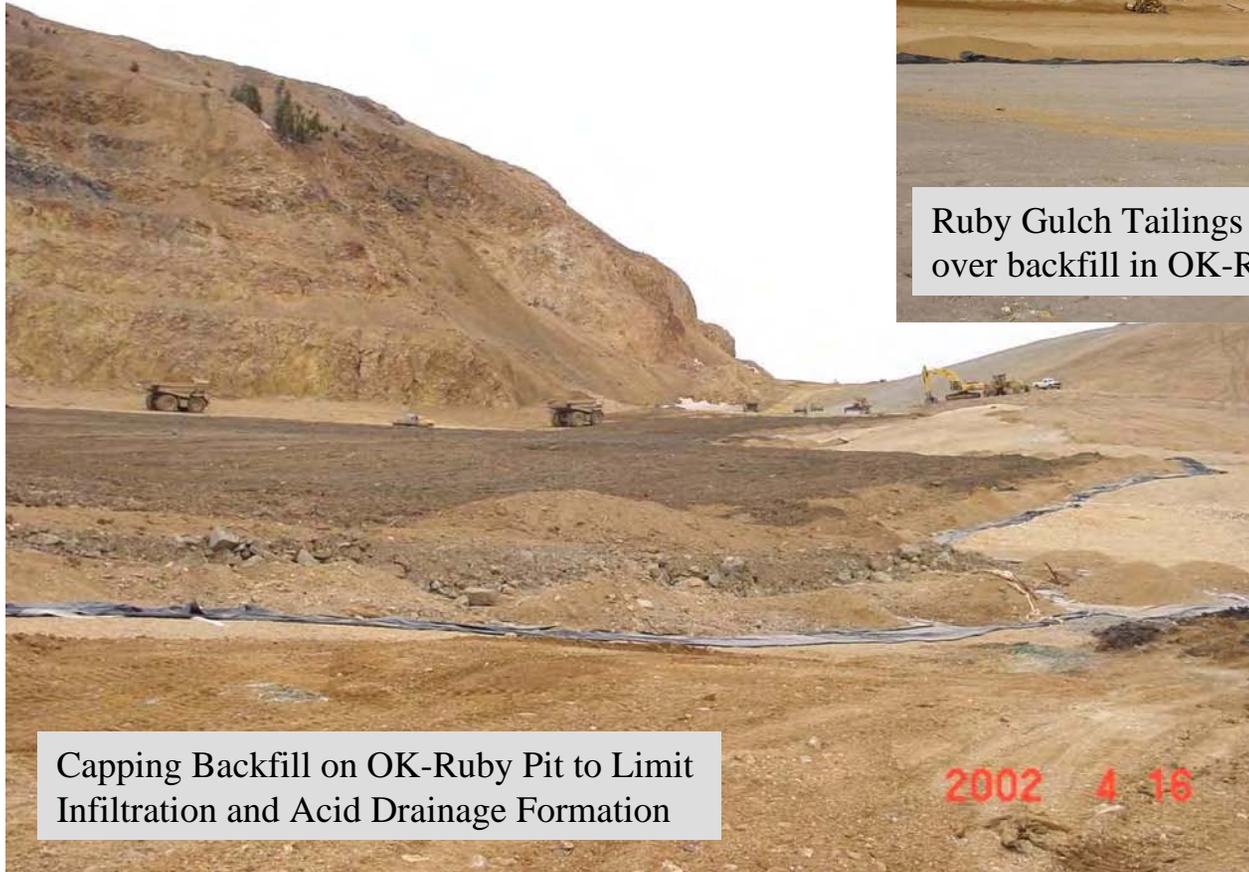
2002 4 16

Capping Backfill on OK-Ruby Pit to Limit
Infiltration and Acid Drainage Formation

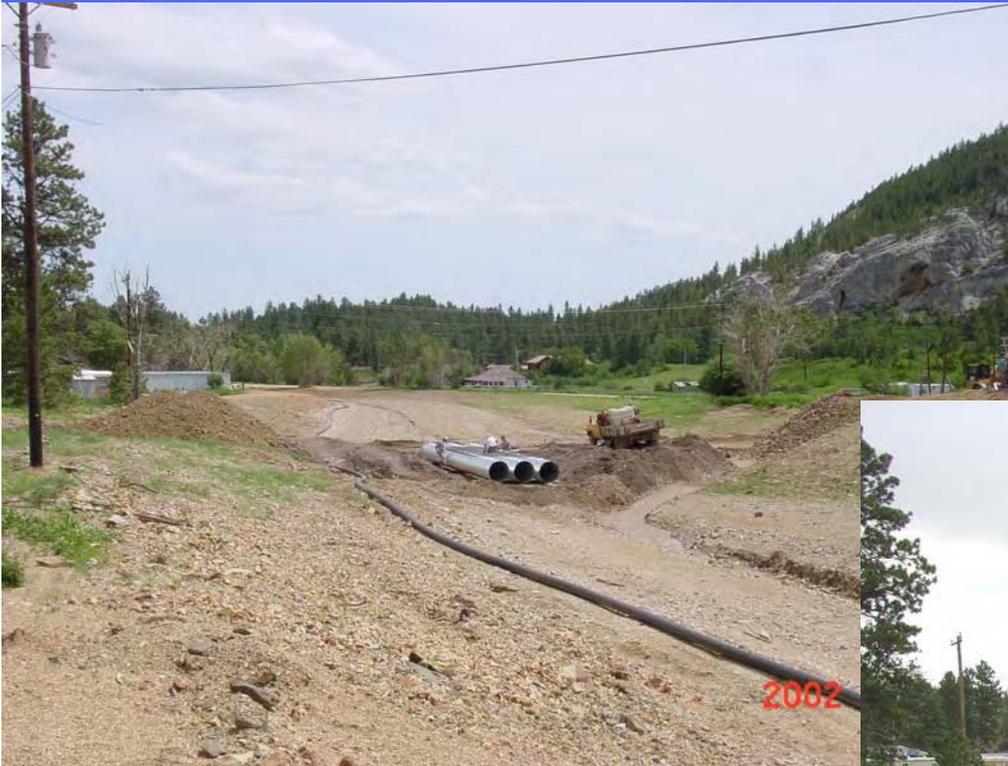
**Ruby Gulch crossing
installation – June 2002**

- Roads removed from stream bottom
- Road crossing installed in 2002

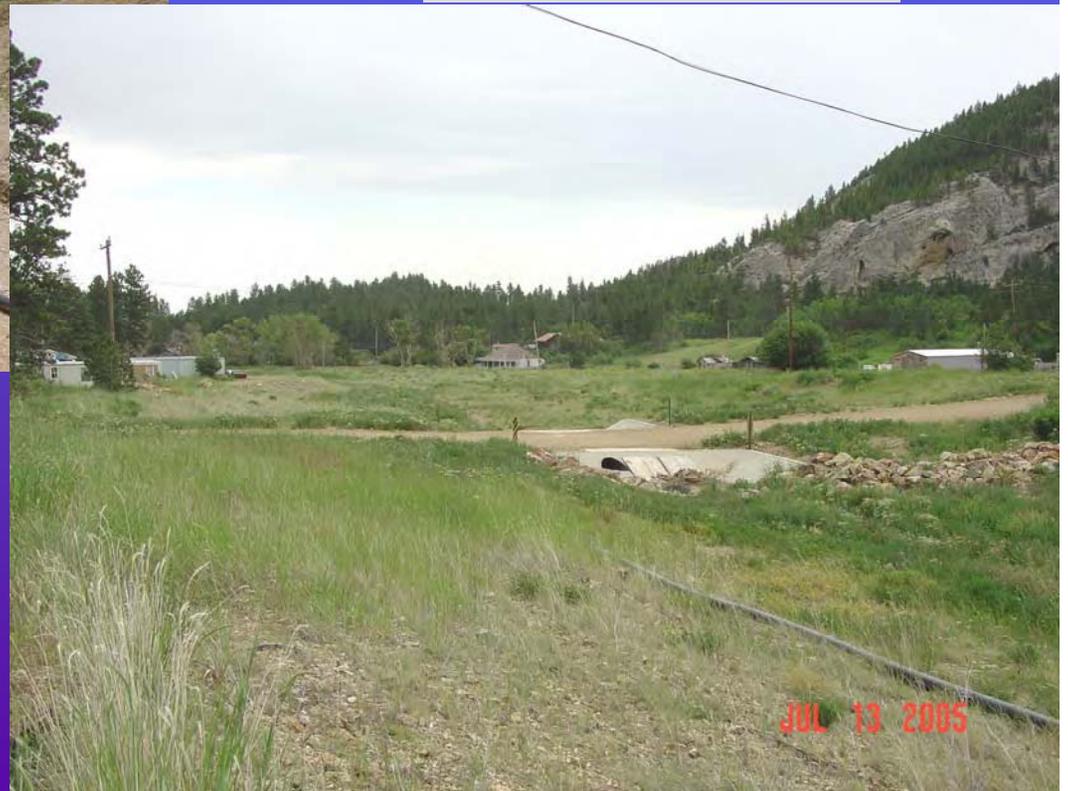
**Ruby Gulch through town
of Zortman – July 2005**

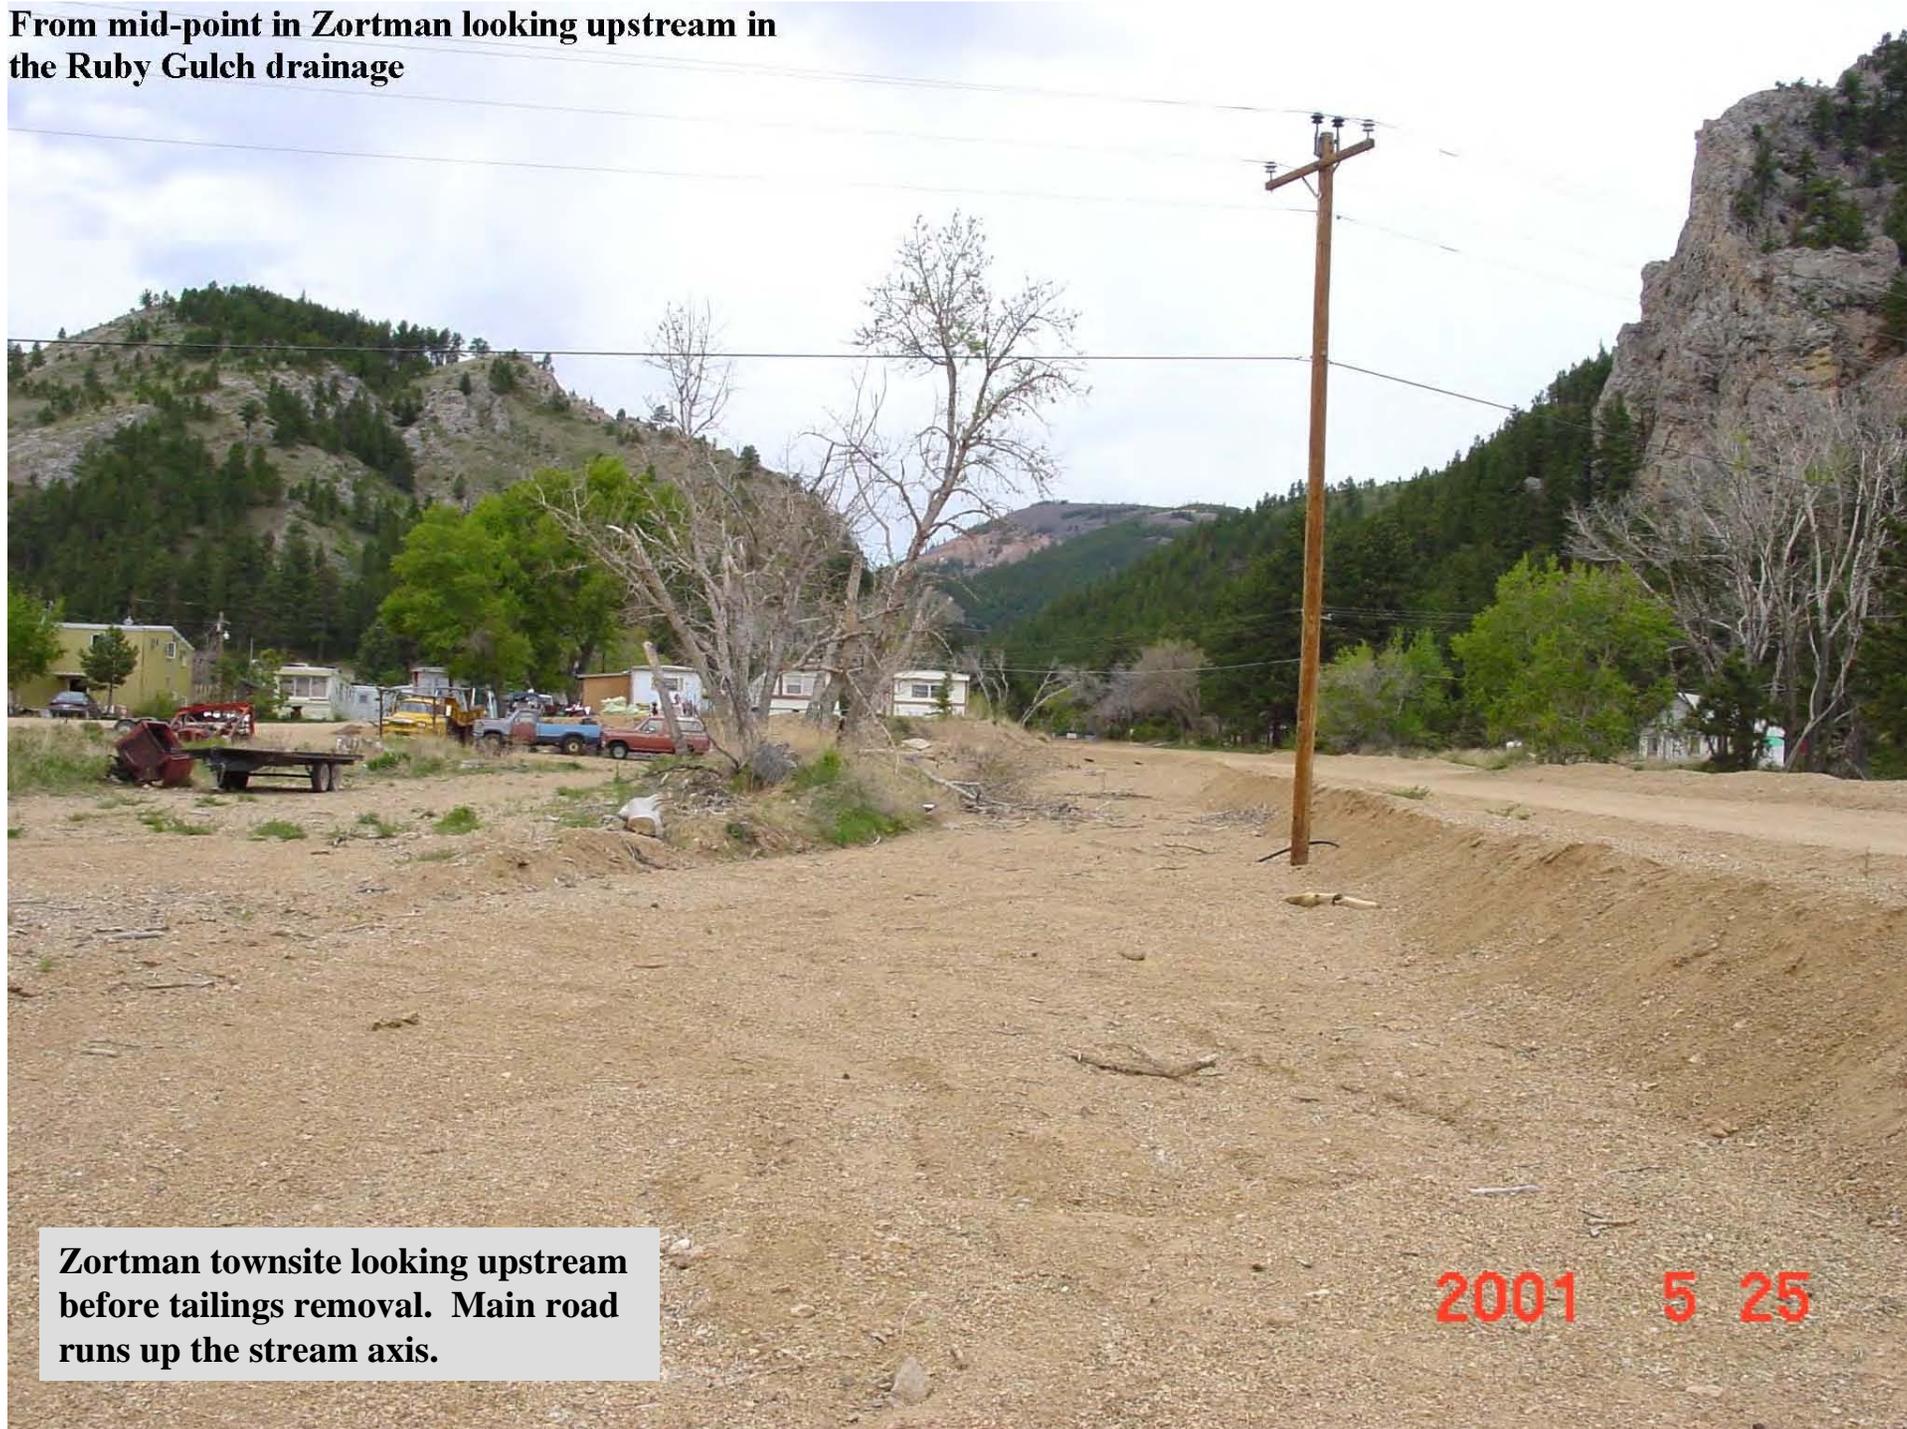
2001 5 25

**Zortman townsite looking upstream
before tailings removal. Main road
runs up the stream axis.**

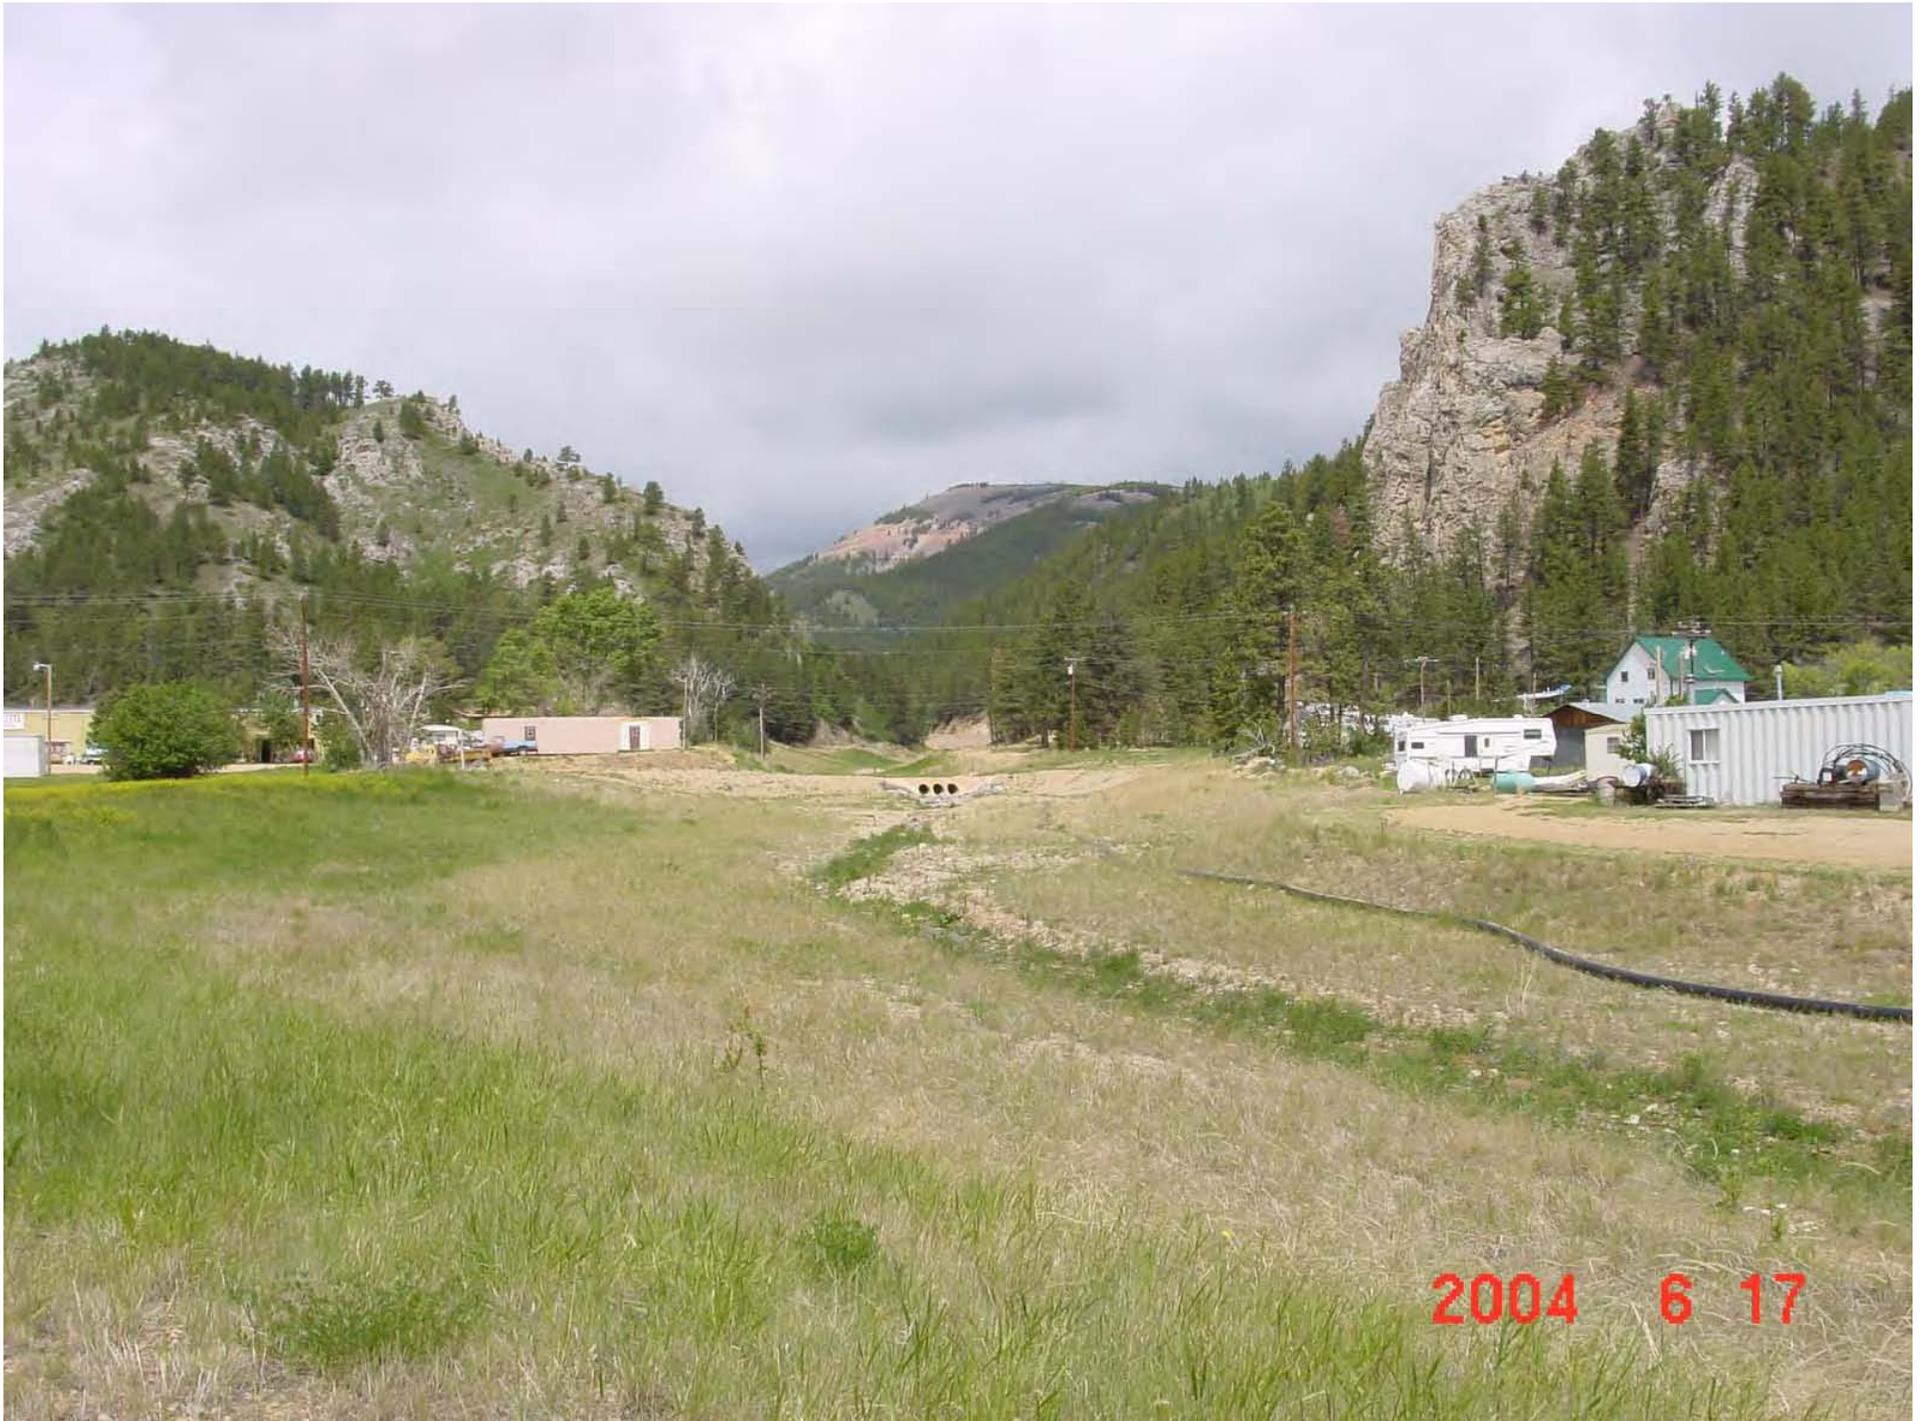
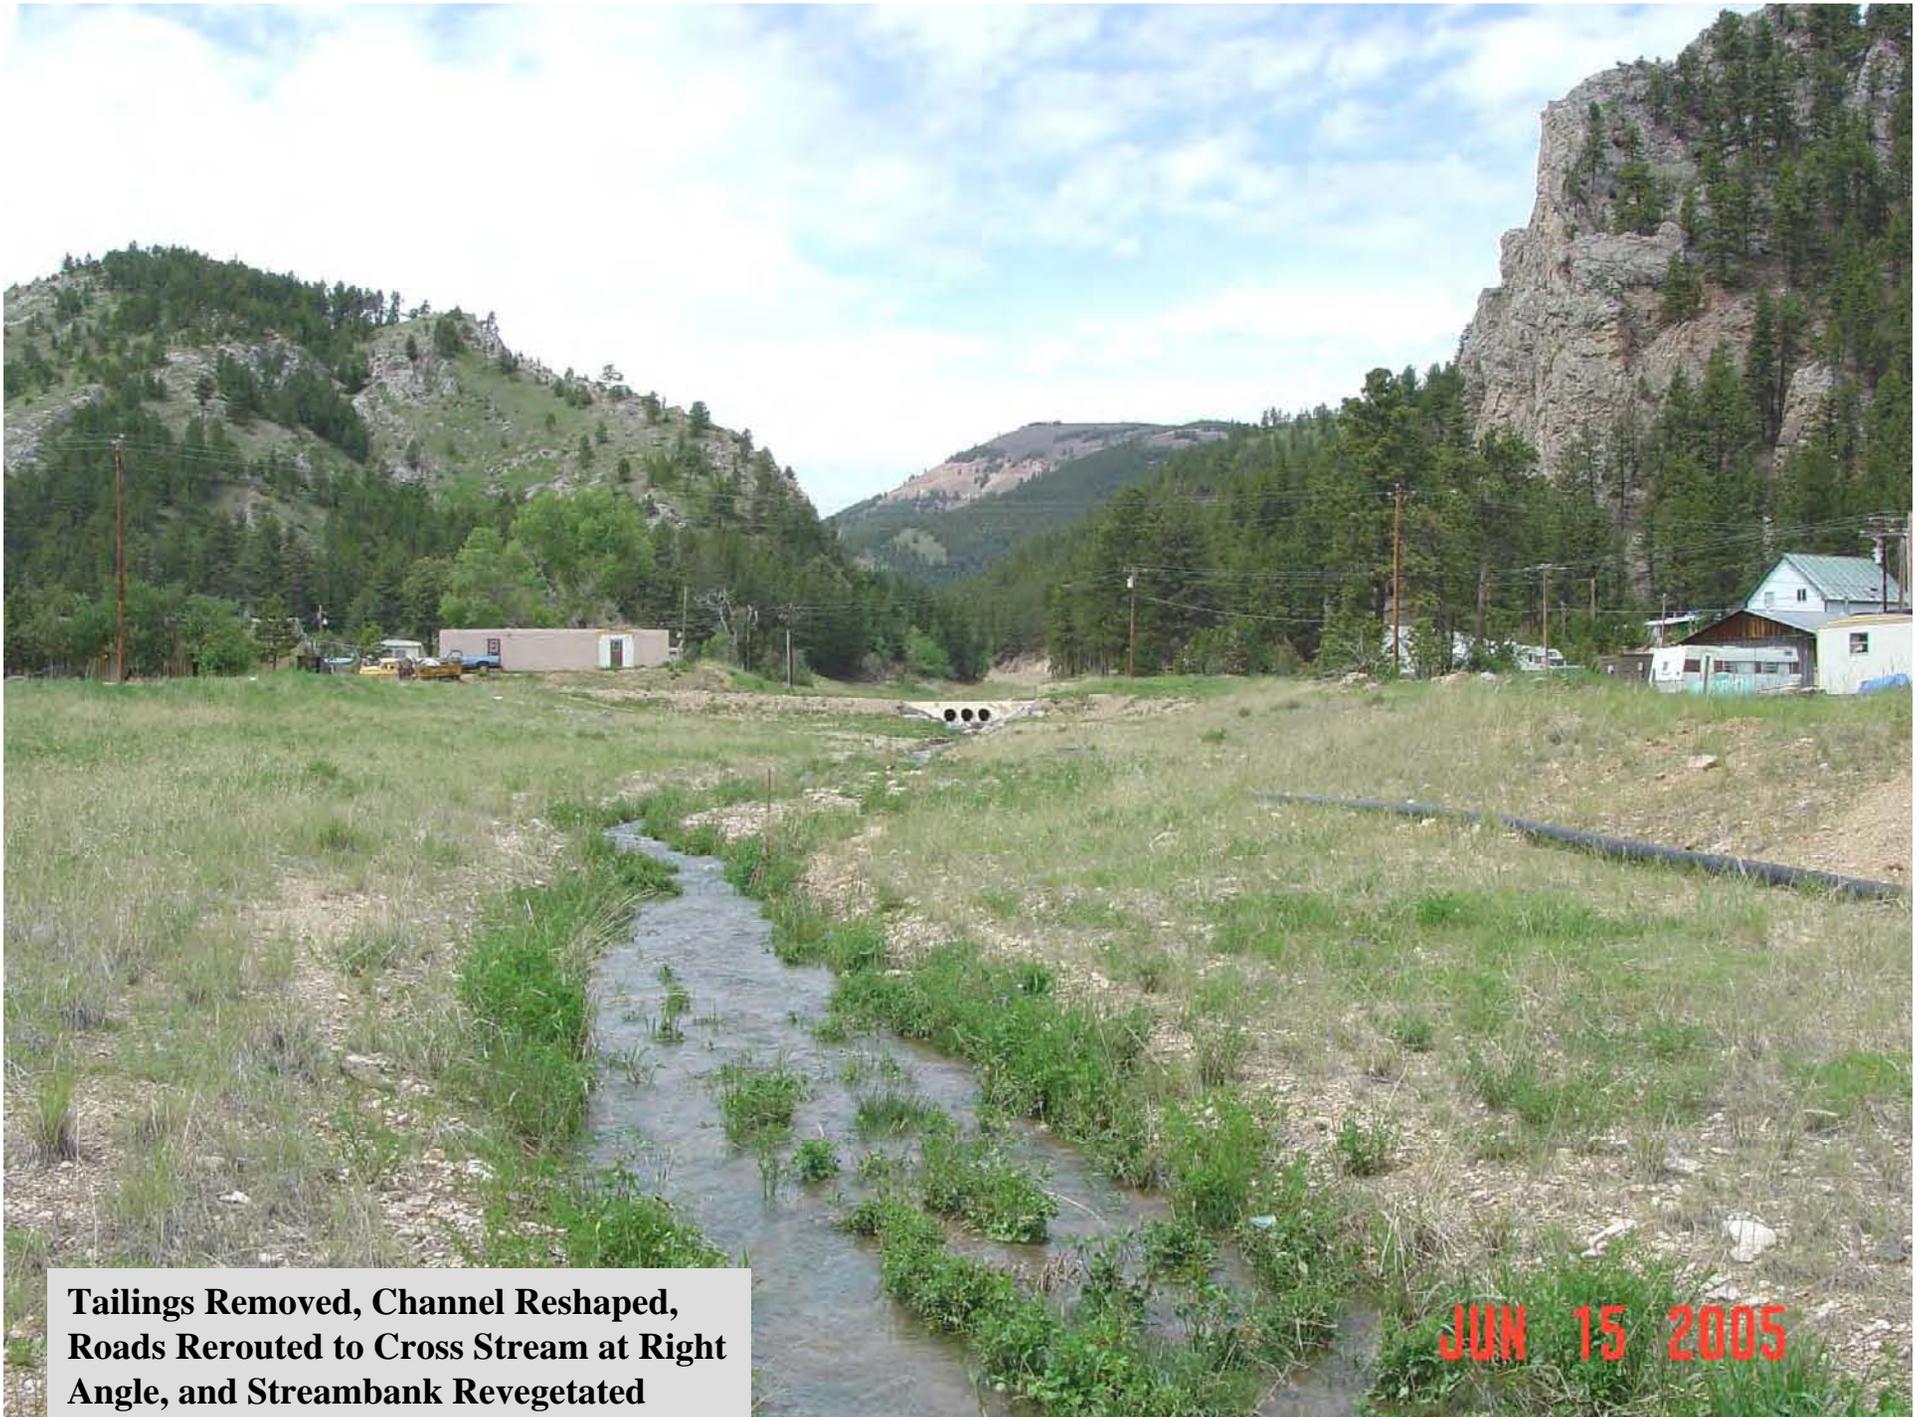
JUN 15 2005

**Tailings Removed, Channel Reshaped,
Roads Rerouted to Cross Stream at Right
Angle, and Streambank Revegetated**

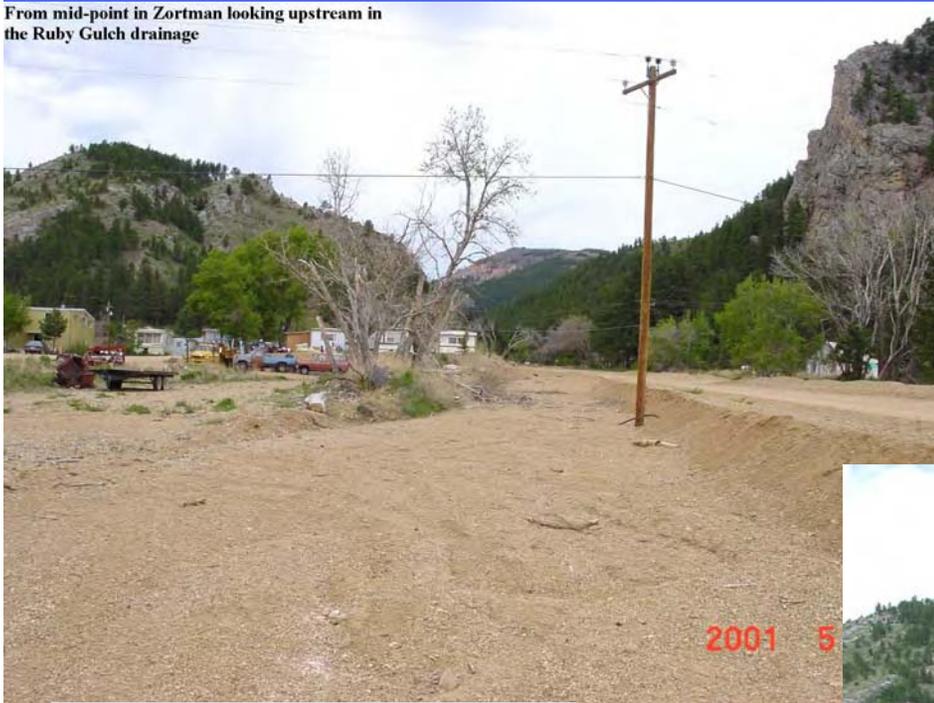
2001 5

Ruby Gulch drainage through town of Zortman – May 2001

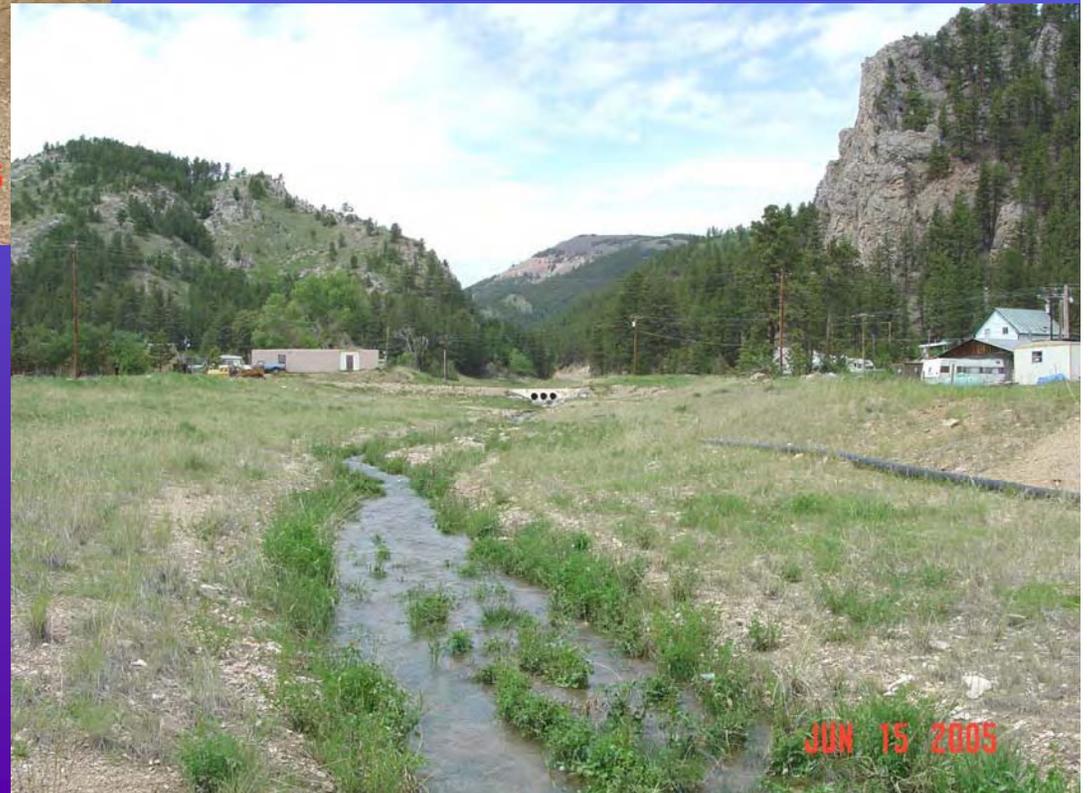
JUN 15 2005

Ruby Gulch drainage through town of Zortman – June 2005

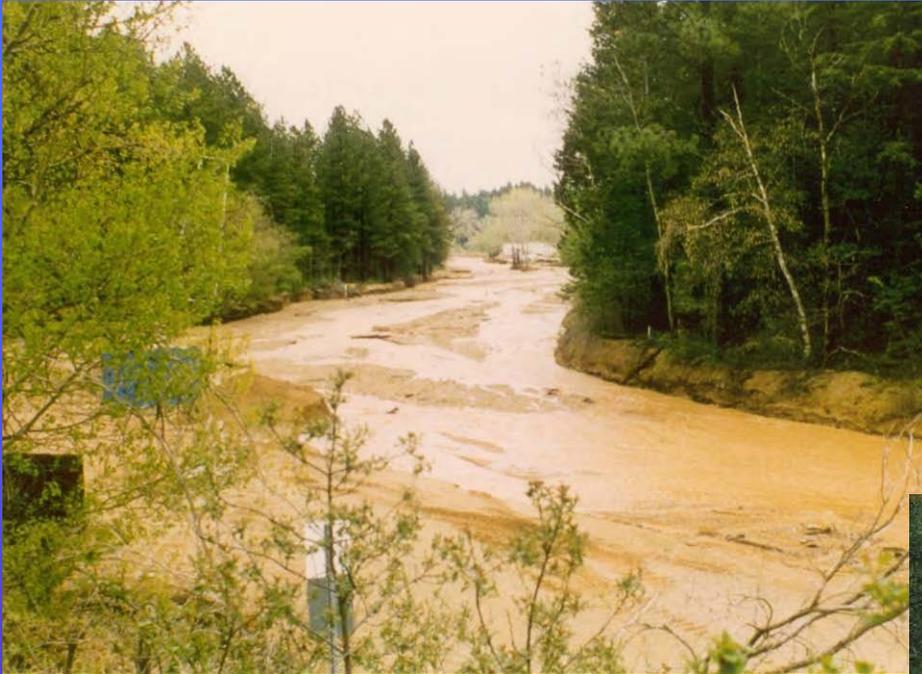
**Ruby Gulch, Upstream
Zortman Townsite,
September 1997**

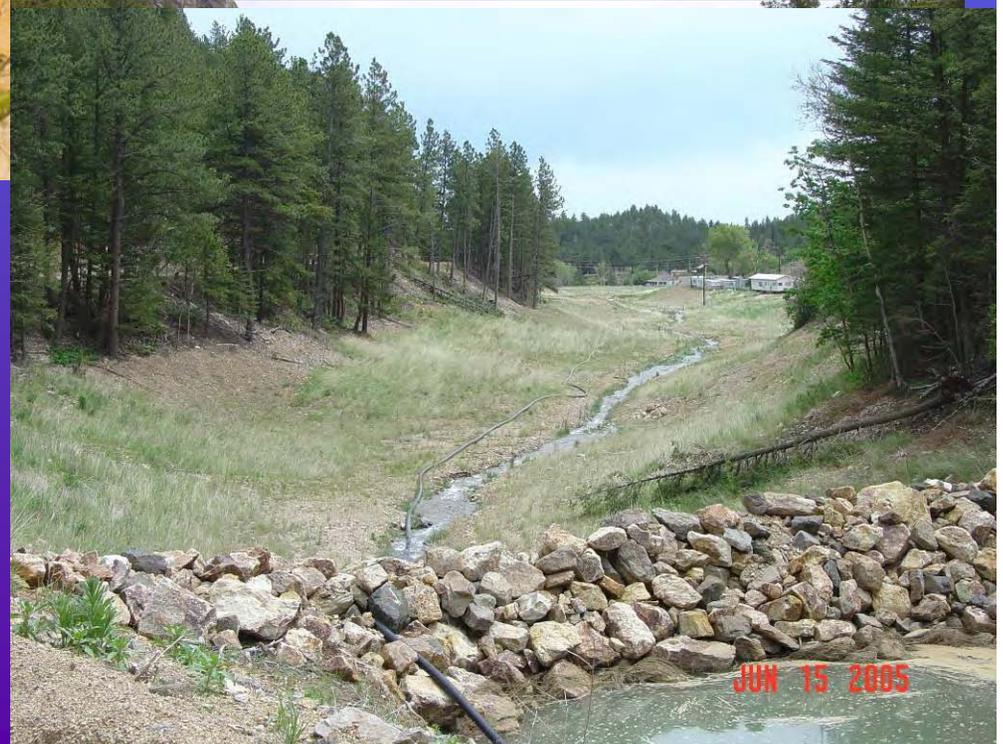
**Ruby Gulch After Tailing Removal
and Erosion Control, June 2005**
